REVIEW OF LANDSCAPE RETAINING WALL

1190 Falcon Drive, Coquitlam

CCIG Project No: V1610407CA

March 28th, 2016

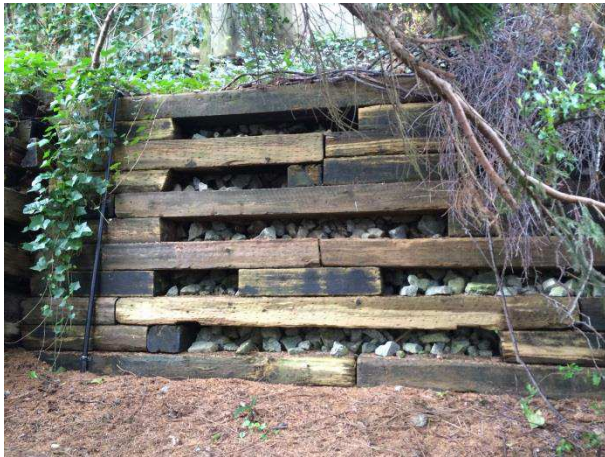
Photograph No. 1

Typical view of the west wood retaining wall.

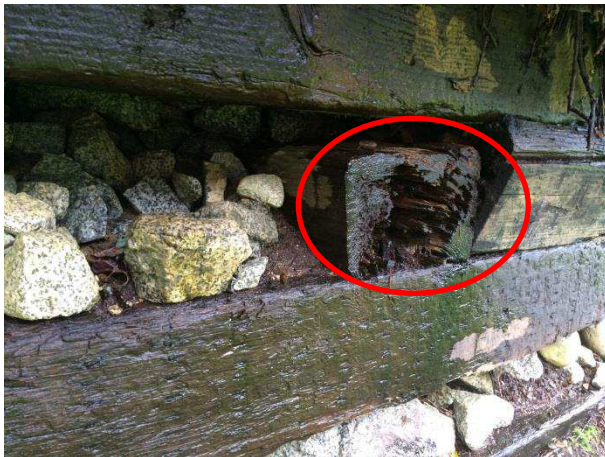
Photograph No. 2

Decay and wetness of the exposed tiebacks was observed.

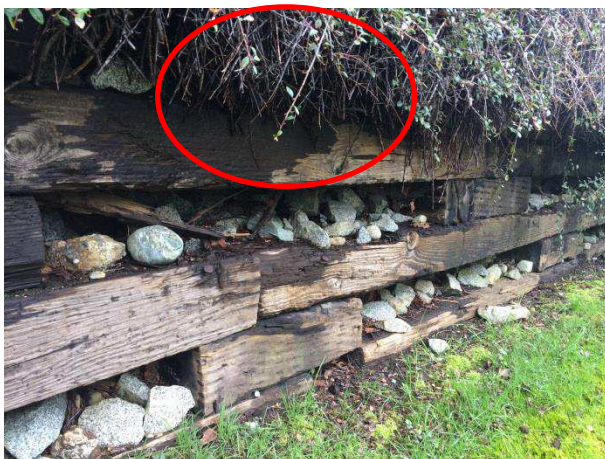
Photograph No. 3

Landscape ground cover grown over the top lumber of the retaining wall causing weather damage and wetness of the lumber.

Removal and upkeep of landscaping would discourage roots from overgrowing and reduce the amount of force applied to the retaining wall.

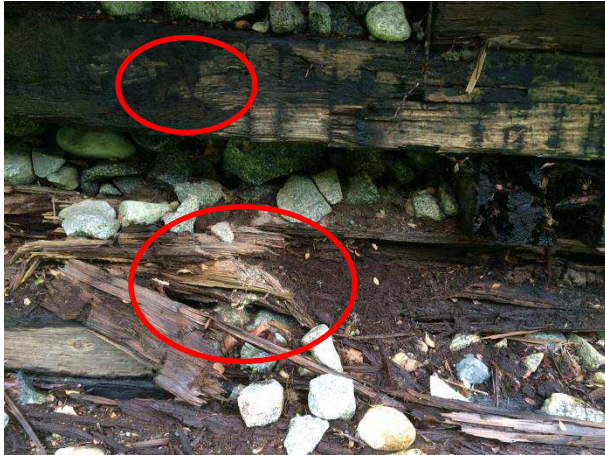
Photograph No. 4

Decay due to weather damage of the lumber was noted throughout the retaining wall.

- 1) Replace sections of the retaining wall that have experienced severe rot/decay. Prior to installation of new lumber, treat wood with wood preservative to prolong the life of the retaining wall.
- 2) Reinforce parts of the retaining wall that have experienced structural movement by anchoring lumber with screws or bolts, where possible. Where the structural integrity of the retaining wall is severely compromised, replacement is recommended.
- 3) Investigate weeping tiles and weep holes to ensure they are functioning as required.

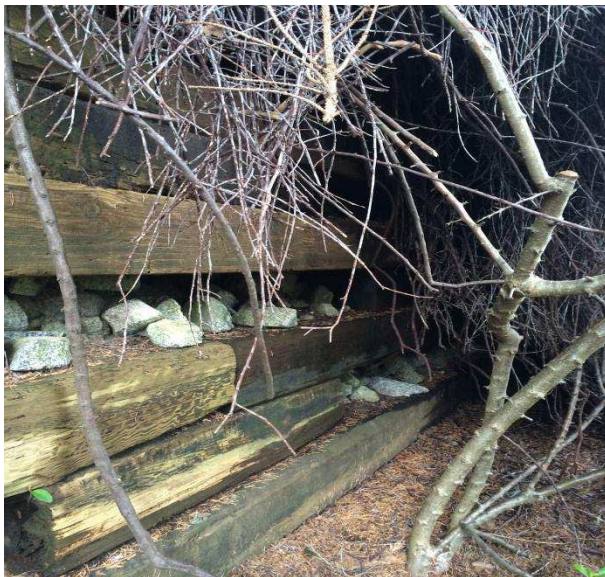
Photograph No. 5

Some areas of the retaining wall were not accessible/ visible due to overgrown foliage.

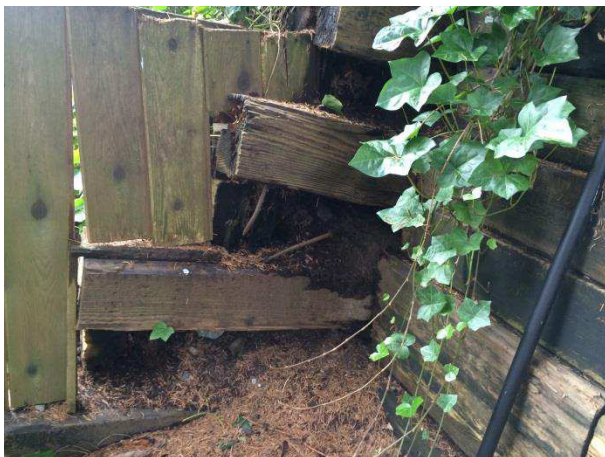
Photograph No. 6

Structural movement and rot/moisture was found at the retaining wall southwest connection to adjacent property.

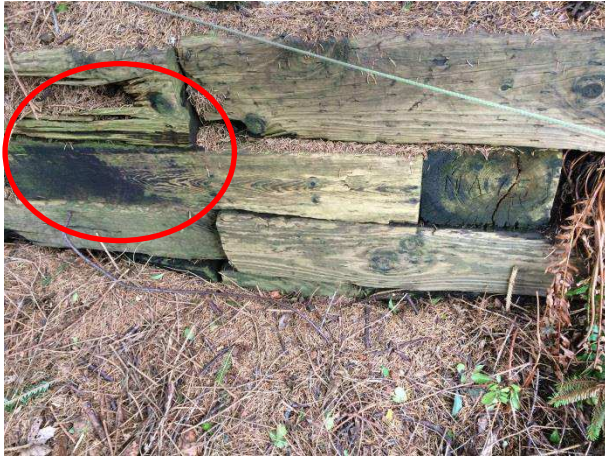
Photograph No. 7

Algae growth was found throughout the west retaining wall.

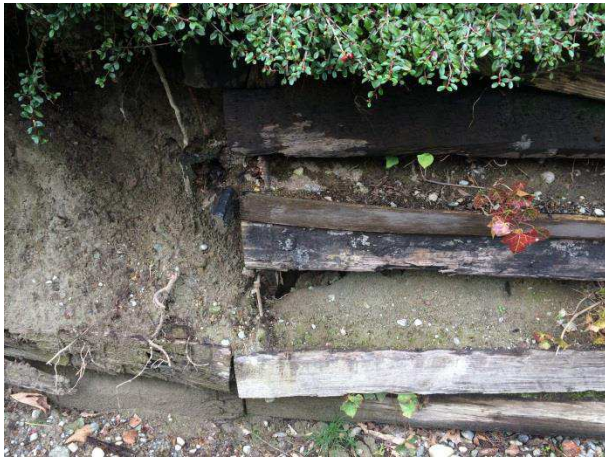
Photograph No. 8

Evidence of significant deteriorated lumber on the west retaining wall especially the mid-section adjacent to unit 44, was observed.

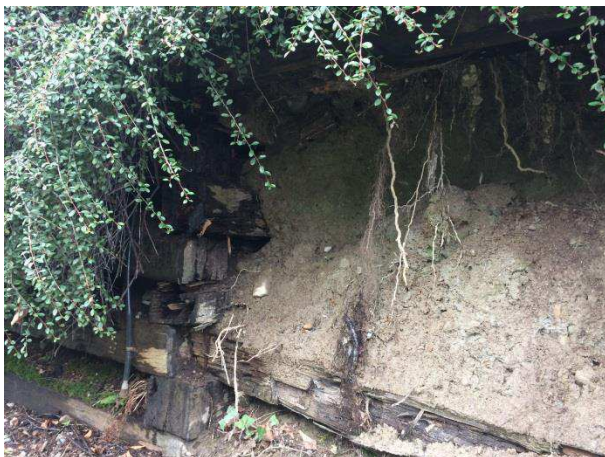
Photograph No. 9

A section of the retaining wall, adjacent to units 40/41, was completely deteriorated and sections of lumber were missing.

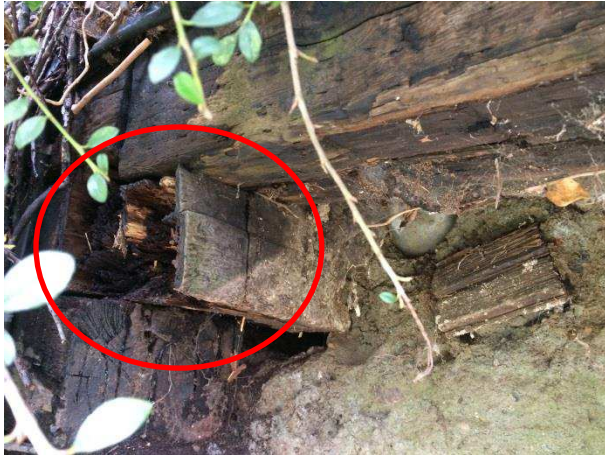
Photograph No. 10

Structural issues were observed, particularly at the mid-section of the wall where deterioration/decay of the tieback lumber is currently supporting the wall.

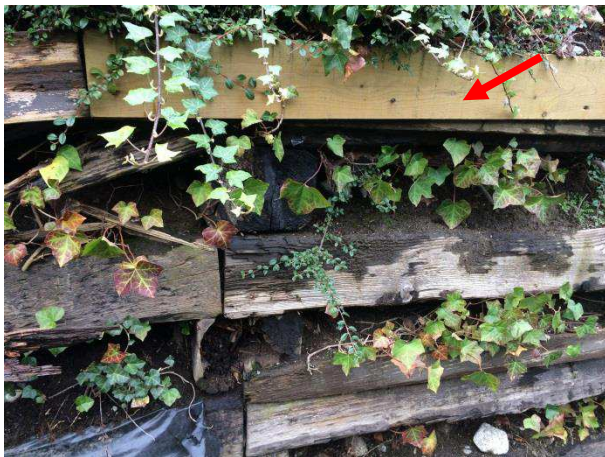
Photograph No. 11

Evidence of recent repair work appears to have been completed.

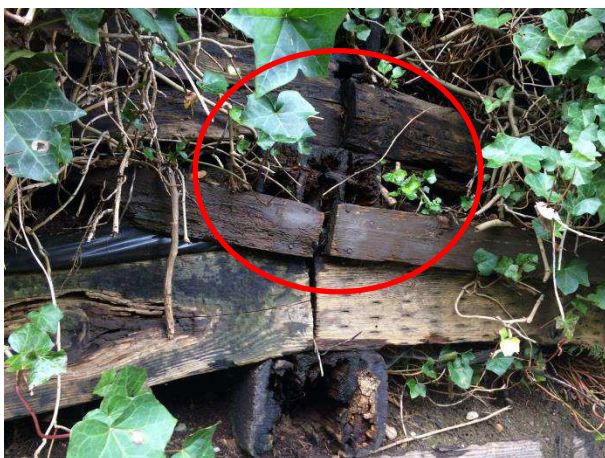
Photograph No. 12

Due to the weight and deterioration of the lumber some tiebacks have collapsed and were protruding from the face of the retaining wall.
